**Milwaukee Street (DOT # 387 094Y)
Public Grade Crossing Closure Study
City of Plymouth, Sheboygan County, Wisconsin**

**Prepared For:
Wisconsin and Southern Railroad LLC**

**Prepared By:
Tom Running,
RRX Consulting LLC
Rail Safety Analyst**

On: March 13, 2015

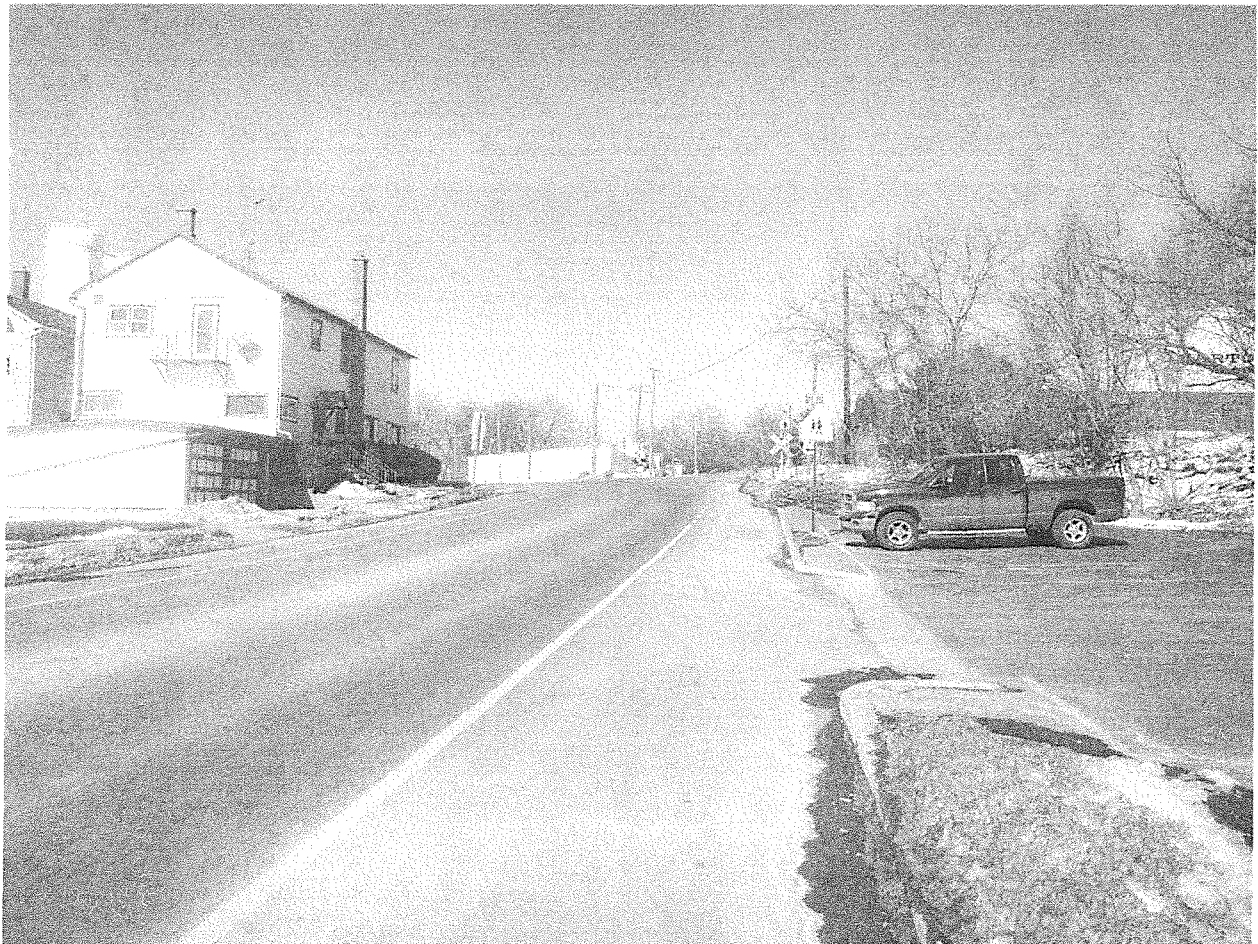
Photo 1 northbound approach

According to WISDOT, the Average Annual Daily Traffic for Milwaukee Street is listed at 3100 vehicles per day. Milwaukee Street is asphalt and 36 feet wide. The roadway in the immediate vicinity of the crossing has a very steep ascending grade from the south of approximately 13 percent. The grade is level from the north. The crossing consists of two tracks. The north track is operational, and the south track is unused and disconnected. The distance from the stop bar to track centerline is 34 feet. Although Milwaukee Street runs north-south, the roadway has a slight westward displacement south of the crossing and its intersection with Main Street, of 10 feet. This has the effect of forcing southbound traffic to face the oncoming northbound traffic lane. This results in confusion as to whether northbound traffic will continue straight on Milwaukee Street, or follow Western Avenue to the left.

Milwaukee Street speed limit is an unposted 25 mph. Assuming a speed of 25 mph, the safe stopping distance is 187 feet. The crossing is visible from greater than 187 feet on both approaches. See Photos 1 and 2

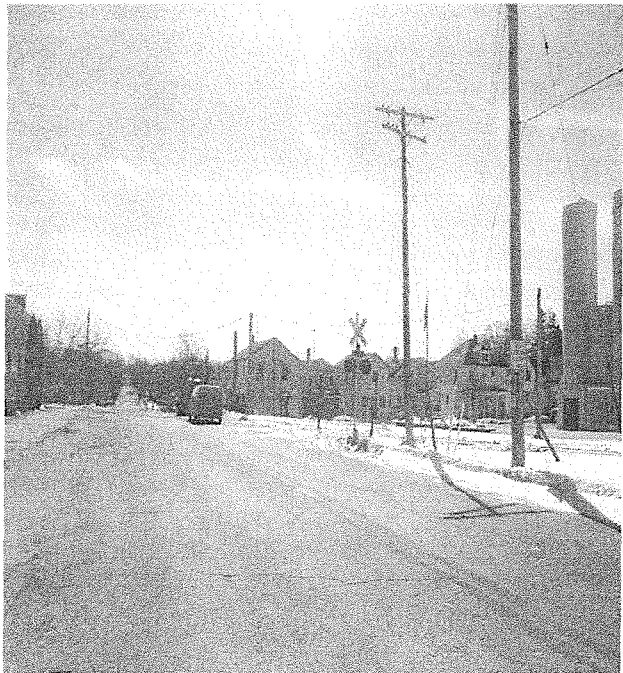
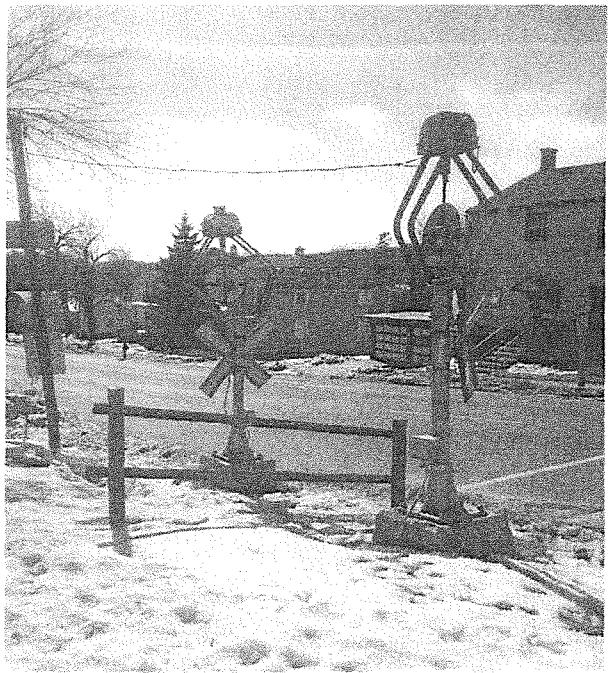
Warning devices for the Milwaukee Street crossing consist of one 8-inch flashing light signal on the southbound approach, one wig-wag signal for the northbound approach, and one wig-wag for facing the approach of Main Street. There is also an 8-inch flashing light signal on the westbound approach of the sidewalk on Main Street. The adjacent crossing of Elizabeth Street also has warning devices consisting of one 8-inch flashing light signal, and one wig-wag. Wig-wags are archaic warning devices, and with no replacement parts available, are impossible to maintain. There is one stop sign on southbound Milwaukee Street for the intersection of Main and Western Avenue. When a vehicle is stopped at the stop sign, the track is fouled. There is also a single 8-inch flashing light signal at the sidewalk for Main Street. The cost to replace the archaic signals at Milwaukee Street is estimated at \$225,000.

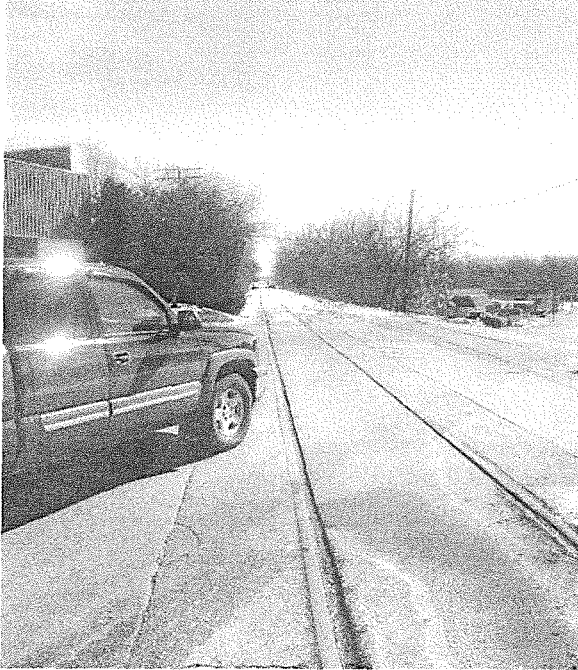
Photo 3

Clearing sight distance is the distance needed to see an approaching train down the track from a stopped point to be able to safely cross the tracks prior to the arrival of a train. Clearing sight distance for the crossing, assuming a train speed of 50 mph, for a WB-50 semitruck is 895 feet. Actual clearing sight distance from a point 12 feet from the nearest rail is in excess of 1,000 feet in all four quadrants. However, clearing sight distance in the northwest is hindered by the LHF skew of the crossing.

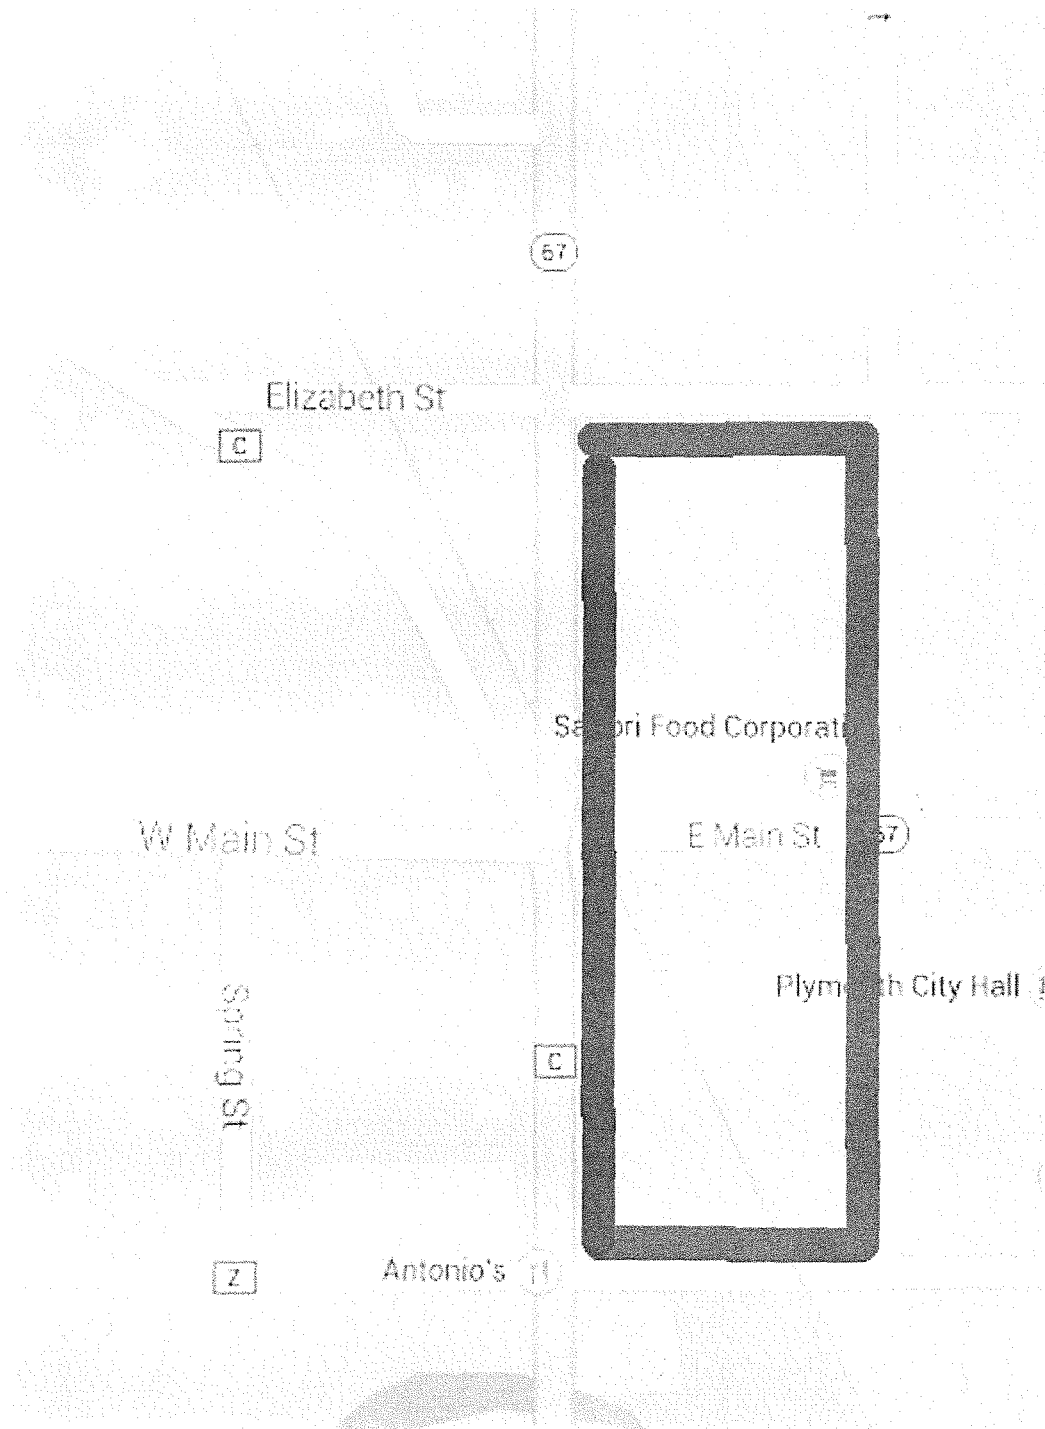
Alternate route 1

As previously noted, the marked route for STH 67 runs one block to the east on Caroline Street, bypassing the crossing. The distance from Elizabeth Street to Mill Street is 850 feet. Milwaukee Street to Caroline Street is 350 feet. This is shown to be an adequate alternate route for traffic on Milwaukee Street, adding only two blocks for a total of 1,550 feet. This route is an additional 700 feet. Another alternate route would be to use Western Avenue and Elizabeth Street. The distance from Main Street to Elizabeth Street is 440 feet. The alternate route is 950 feet, for an increase of 510 feet. Turn angle from Western Avenue to Elizabeth Street is 40 degrees, so a curb radius improvement would aid in this turn. Motorists, and particularly emergency vehicles, would have minimal delays by the closure of Milwaukee Street.
